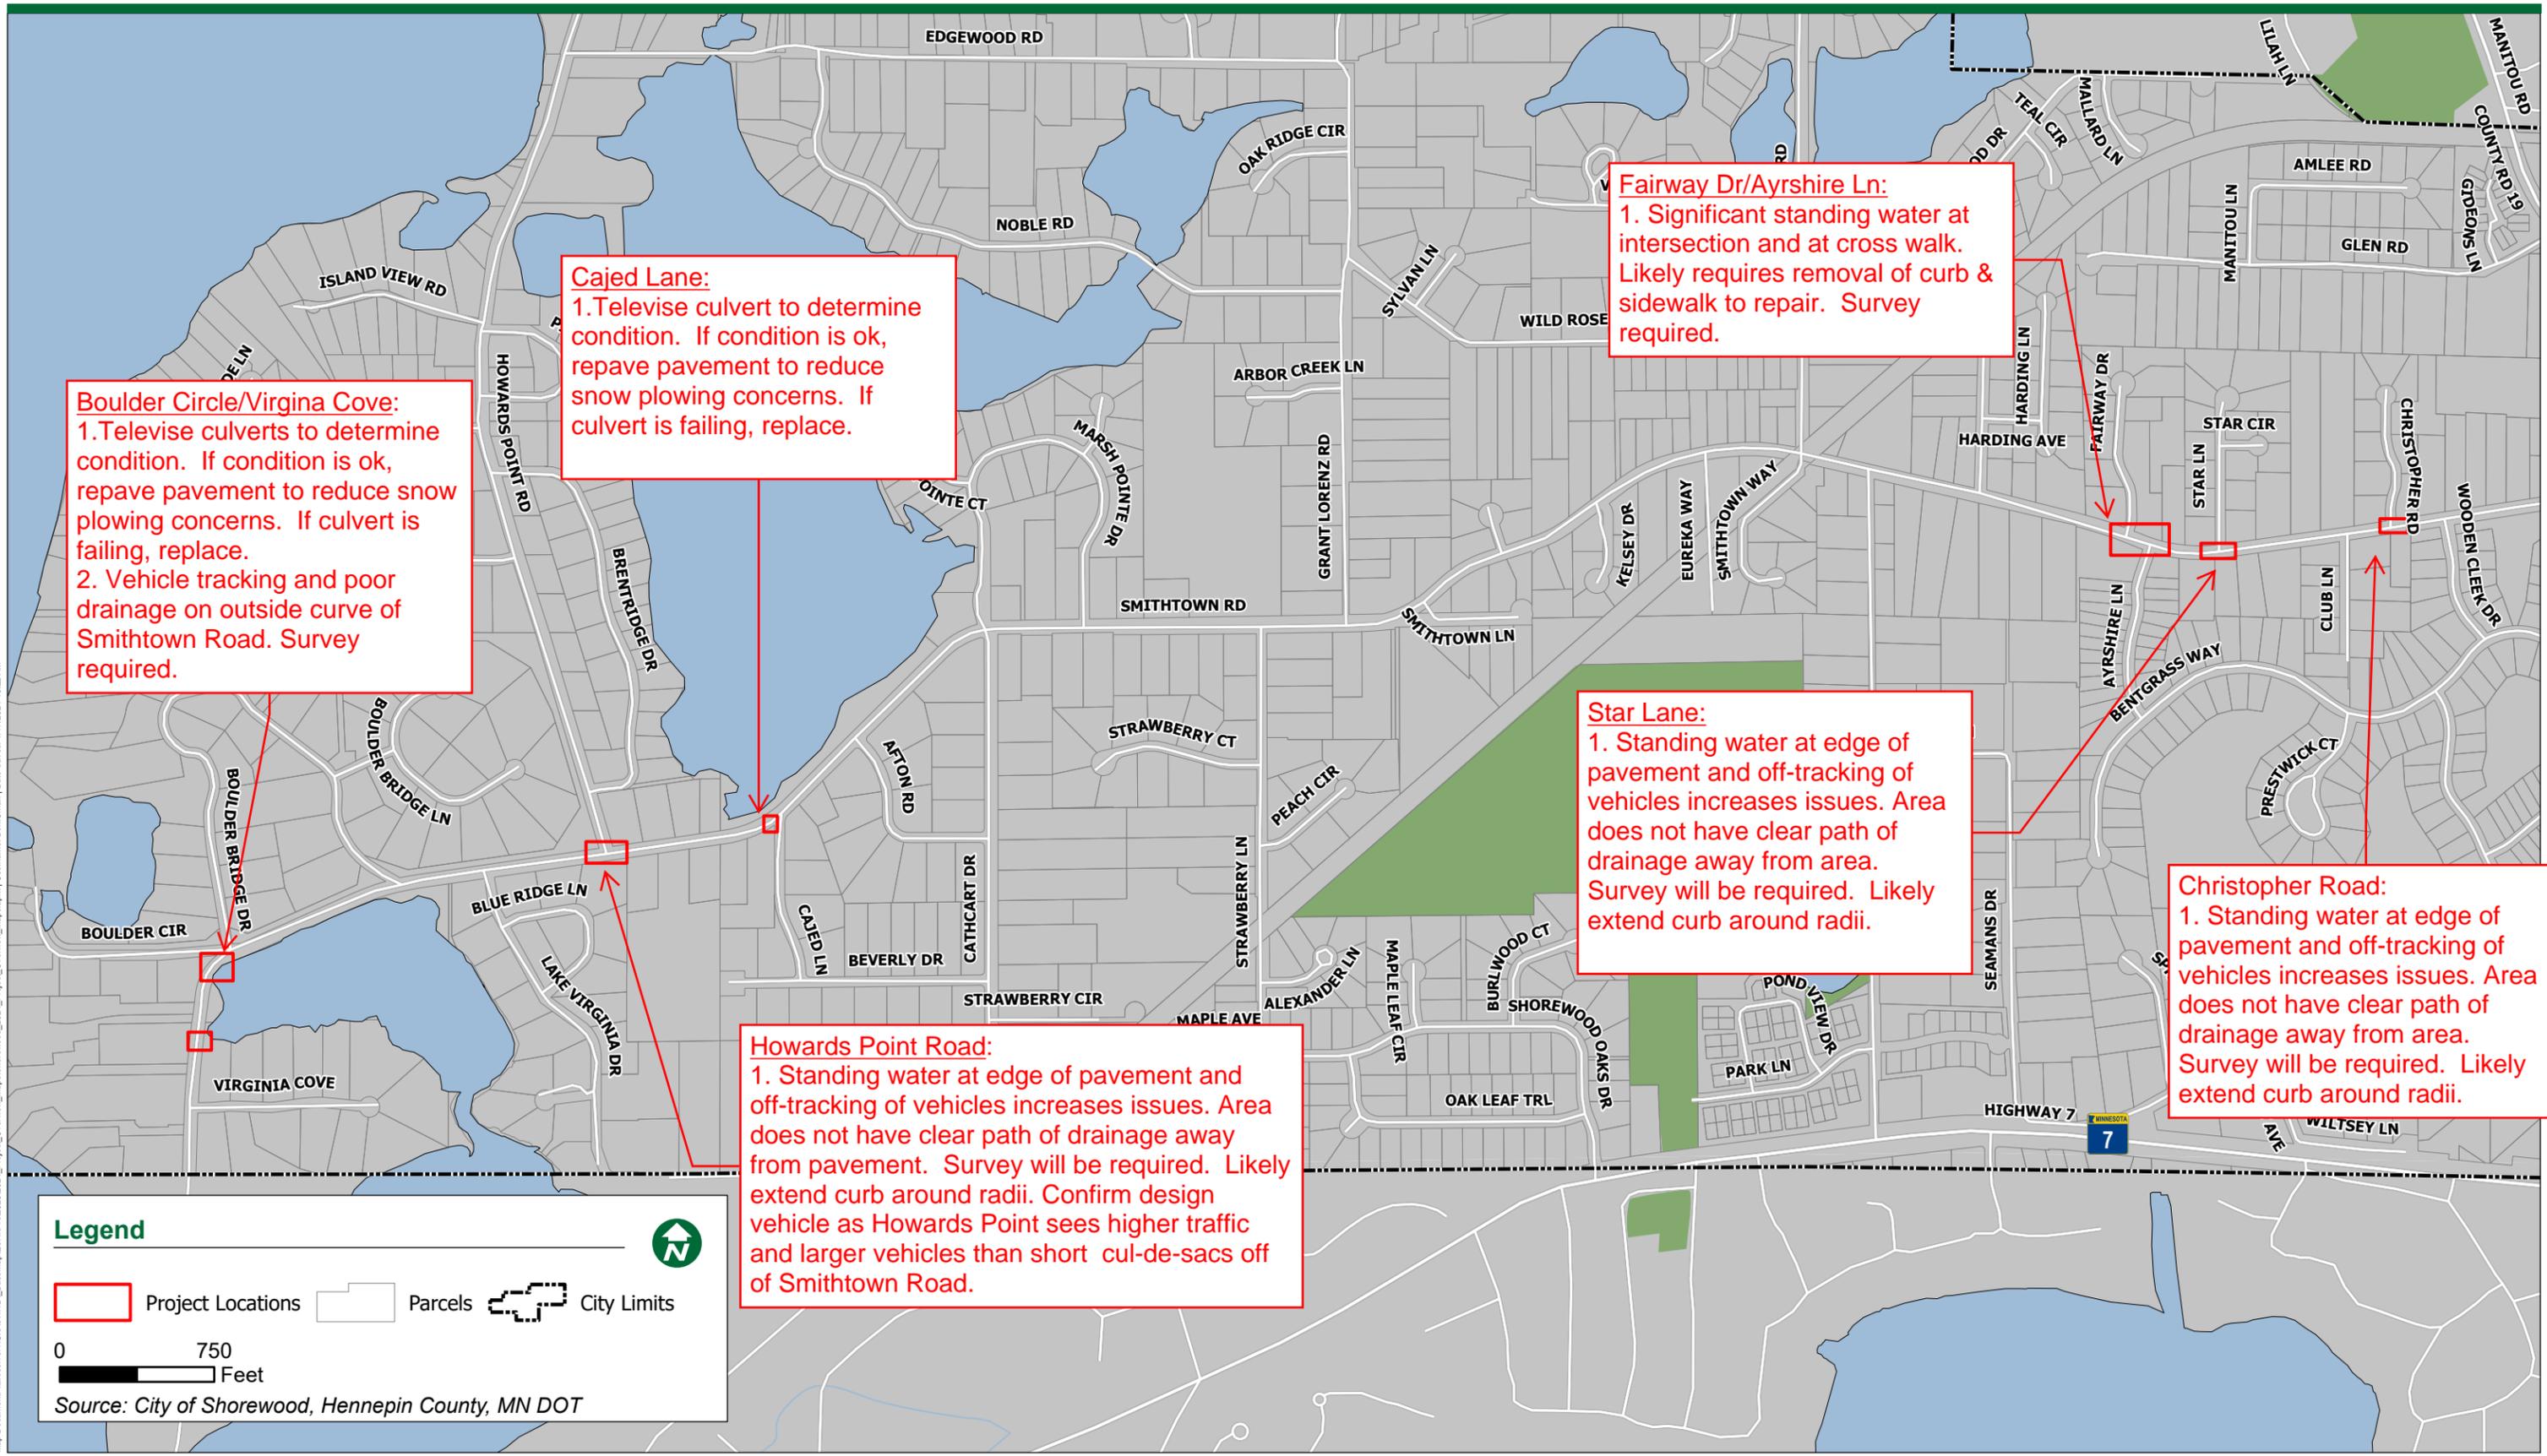
Boulder Circle/Virginia Cove:
1. Televisc culverts to determine condition. If condition is ok, repave pavement to reduce snow plowing concerns. If culvert is failing, replace.
2. Vehicle tracking and poor drainage on outside curve of Smithtown Road. Survey required.

Cajed Lane:
1. Televisc culvert to determine condition. If condition is ok, repave pavement to reduce snow plowing concerns. If culvert is failing, replace.

Fairway Dr/Ayrshire Ln:
1. Significant standing water at intersection and at cross walk. Likely requires removal of curb & sidewalk to repair. Survey required.

Star Lane:
1. Standing water at edge of pavement and off-tracking of vehicles increases issues. Area does not have clear path of drainage away from area. Survey will be required. Likely extend curb around radii.

Howards Point Road:
1. Standing water at edge of pavement and off-tracking of vehicles increases issues. Area does not have clear path of drainage away from pavement. Survey will be required. Likely extend curb around radii. Confirm design vehicle as Howards Point sees higher traffic and larger vehicles than short cul-de-sacs off of Smithtown Road.

Christopher Road:
1. Standing water at edge of pavement and off-tracking of vehicles increases issues. Area does not have clear path of drainage away from area. Survey will be required. Likely extend curb around radii.
